**UPFITTER INTEGRATION Bulletin 101.1**

SUBJECT: Chassis Upfit Electrical Connections MODEL YEARS: 2024 & Beyond AFFECTED MODELS: UU Model THREE INITIATION DATE: 08/29/2023 REVISION: 10/12/2023

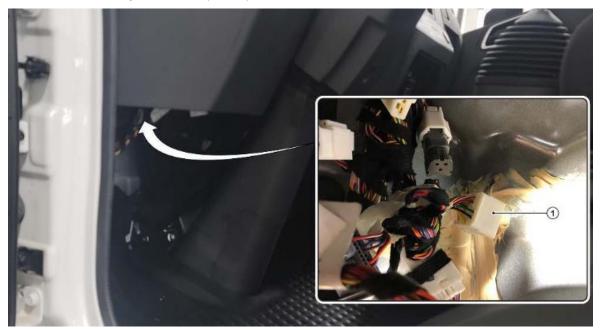
-Cab Interior Auxiliary Connector (Item 1)

- Pinout Map / Cab Interior Connector

Auxiliary interface Branch and sleeve tied back to trunk line
