SUBJECT: Upfit Body Mounting Guidelines MODEL YEARS: 2024 & Beyond AFFECTED MODELS: UU Model THREE INITIATION DATE: 08/29/2023 REVISION: 10/05/2023

Reference; Mullen U.I. Bulletin #101

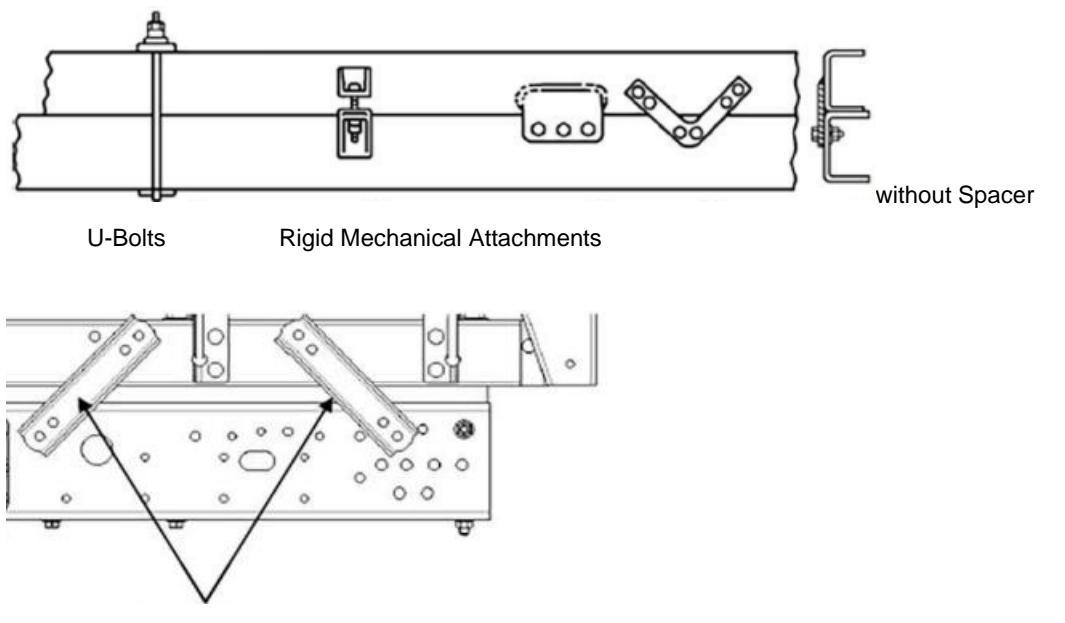
Acceptable types of attachments.

Shear Plates (with Frame Spacer)

Proper Upfit Body mounting secures and distributes load over the entire chassis for rigid attachment of Upfit Body to chassis. Continuous mechanical contact to the frame rails fore and aft of the rear axle is necessary for proper load transfer and distribution. Full perimeter use of the load bearing top-of-frame surface contact with hardwood spacers (or equivalent) is strongly recommended. Generous use and placement of U-Bolts and Shear Plates utilizing existing frame rail holes insure proper mechanical attachment. Use proper premium grade fasteners for rigid mechanical attachment of Upfit Body to chassis mounting areas. Welding is permitted in low stress areas of the frame (aft of rear spring shackles).

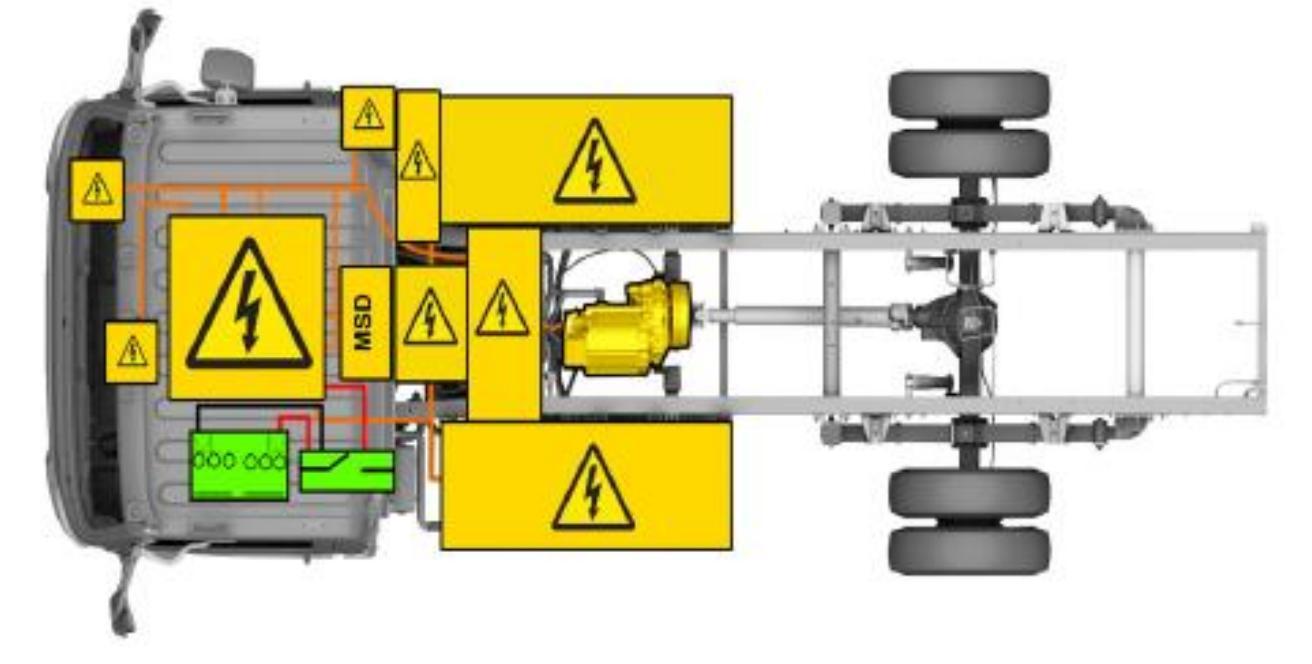
• Regarding HIGH VOLTAGE Batteries/Components & Wiring.

- 1) Maintain a minimum static clearance of 150mm / 3" between frame rail mounted HIGH VOLTAGE Batteries/Components/Wiring and Upfit Body/Equipment.
- 2) Do not alter or relocate HIGH VOLTAGE components from the OEM chassis location.
- 3) Do not mount Upfit Body/Equipment to the HIGH VOLTAGE Batteries/Components/Wiring.

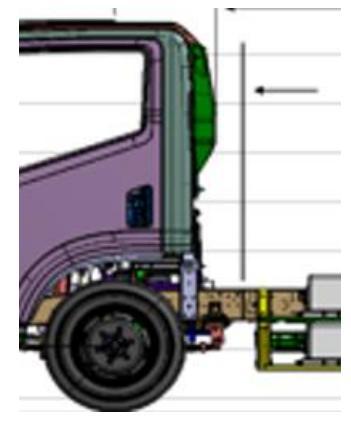
Regarding Cab to Upfit Body Gap

- 1) Maintain a minimum fore/aft clearance of 228mm / 9" from to back-of-cab to upfit body/equipment for service and access to chassis components.
- 2) Do not mount any equipment in the Cab to Upfit Body Gap
