**SUBJECT: Trimming chassis mounted Battery Cage Brackets**  
**MODEL YEARS: 2024 & Beyond**  
**AFFECTED MODELS: UU Model THREE**  
**INITIATION DATE: 08/29/2023**  
**REVISION: 10/05/2023**

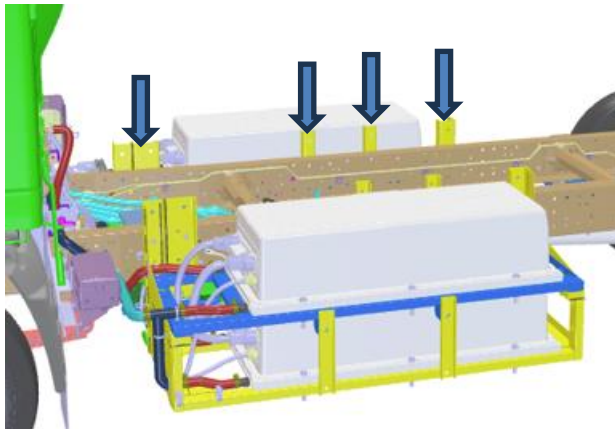
**Description of Concern:** Some chassis mounted Battery Cage Brackets that run vertically attached to the outside frame rail may be intrusive to upfit body mounting. These brackets can be trimmed down based on instruction below. If bracket height is not a concern, they can be left as is.

- Trim vertical brackets down with a compatible reciprocating saw, flush to top of frame. Gaseous Torch cutting is not recommended.

- Remove any burrs and sharp edges off shortened brackets. Seal any bare metal areas with chassis paint.
- Once completed restore any disabled chassis systems. Follow Mullen UI Best Practices Safety Protocol.
